Effect of Crack Opening on Penetrant Crack Detectability

Space Grant Internship
June 8 – August 14

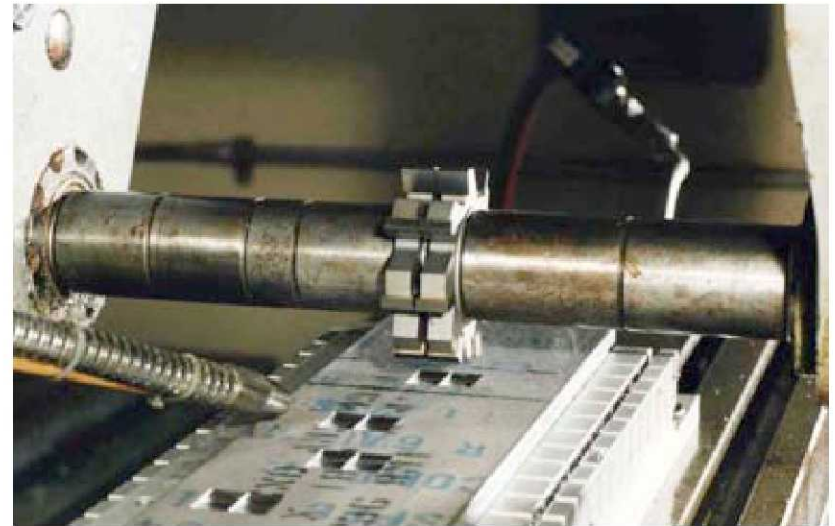
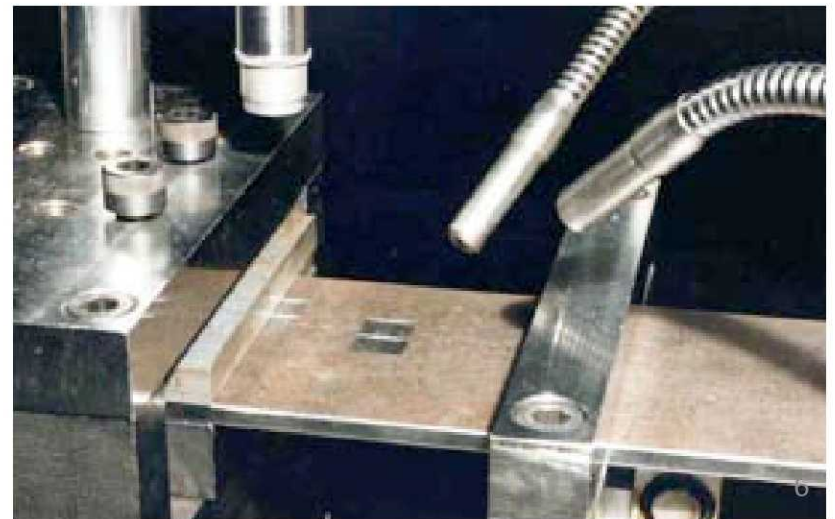
JSC Titanium POD Specimens

- Semi-circular grooves cut into 4"x18" Ti Bar
- EDM slots placed in rib between grooves
- Fatigue cracks created by bending
- The grooves were machined off after cracking
- Surfaced etched to remove smeared metal that was covering the cracks

- Assessment of Contractor's 2008 qualification testing generated several questions about the quality of JSC's POD specimens
- JSC's POD specimens have "V" shape from etching
- Do not know how the width of the crack opening affects the crack detectability
- Cracks were contaminated with debris after returned to JSC from the Contractor

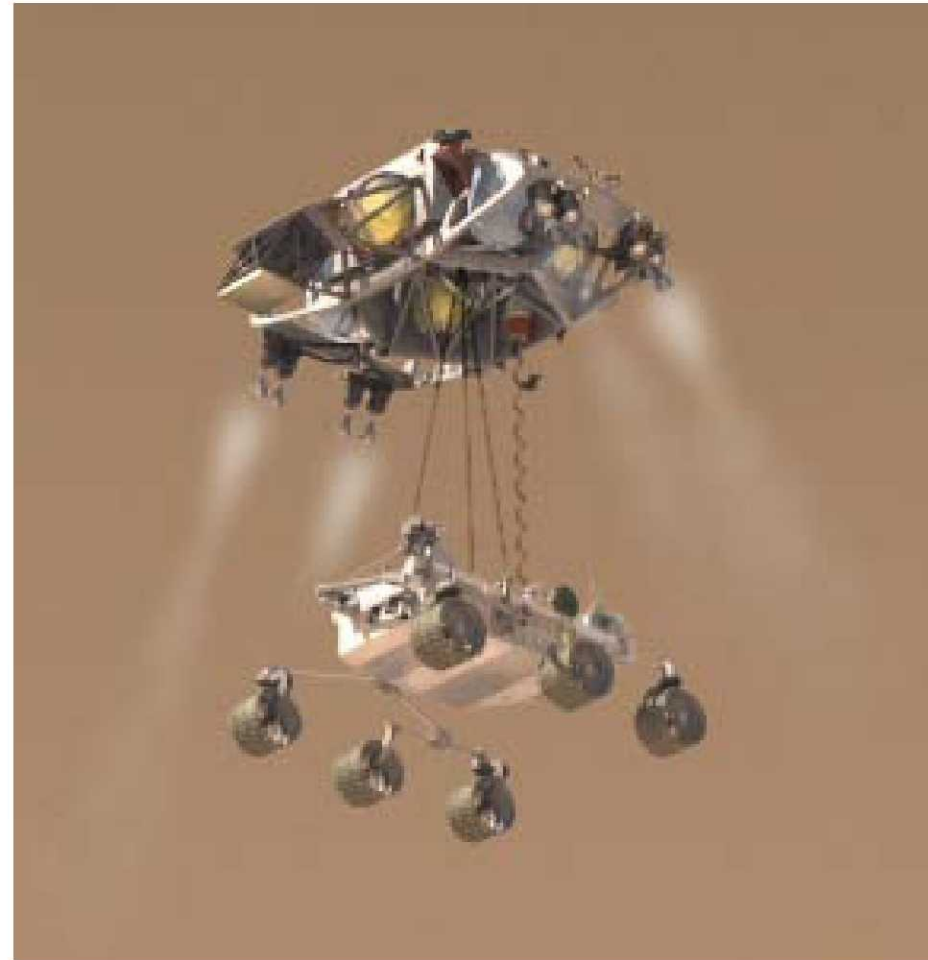
- A NASA contractor required to pass POD test to build pressure vessels for Mars Science Laboratory
- Another NASA contractor could not find ultra-tight cracks in shuttle FCV poppets using fluorescent penetrant
 - Rely on eddy current testing to approve poppets for flight
 - Researching root cause of cracks at WSTF

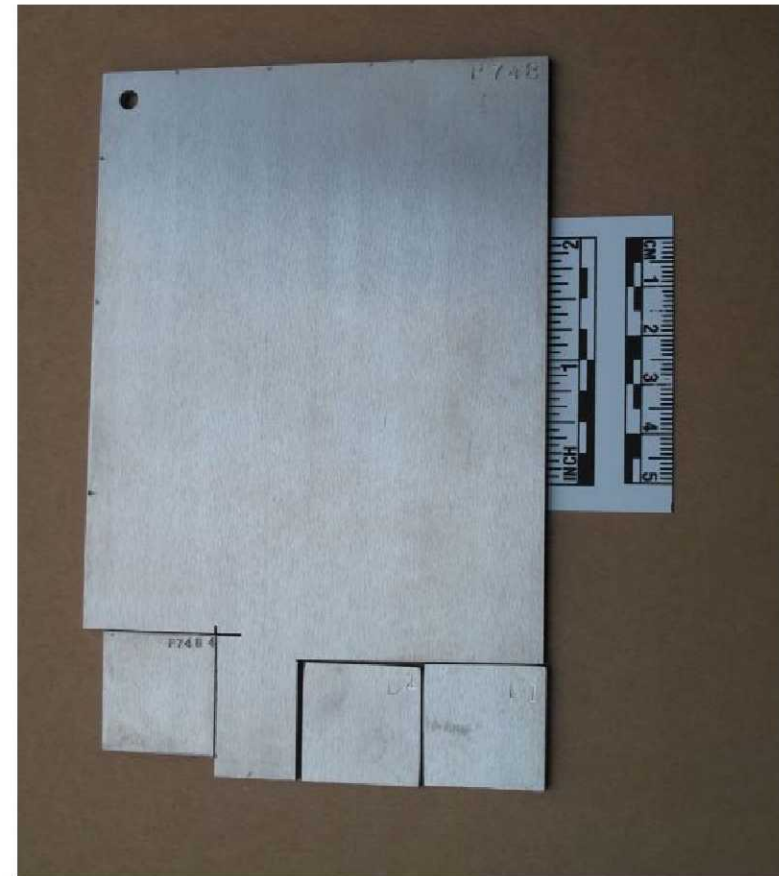
"V" Investigation

- Cut out 1" square with the crack centered using diamond cut-off saw
- Document initial condition with SEM
- Perform Fluorescent penetrant
 - Spot of penetrant covering crack, P-136E
 - 15 – 30 minute dwell time
 - Dry wipe and solvent wipe
 - Photograph pre-developed state
 - Apply developer from aerosol spray can
 - Photograph post-developed state
 - Dry wipe off developer and repeat development process if necessary
 - Clean specimen

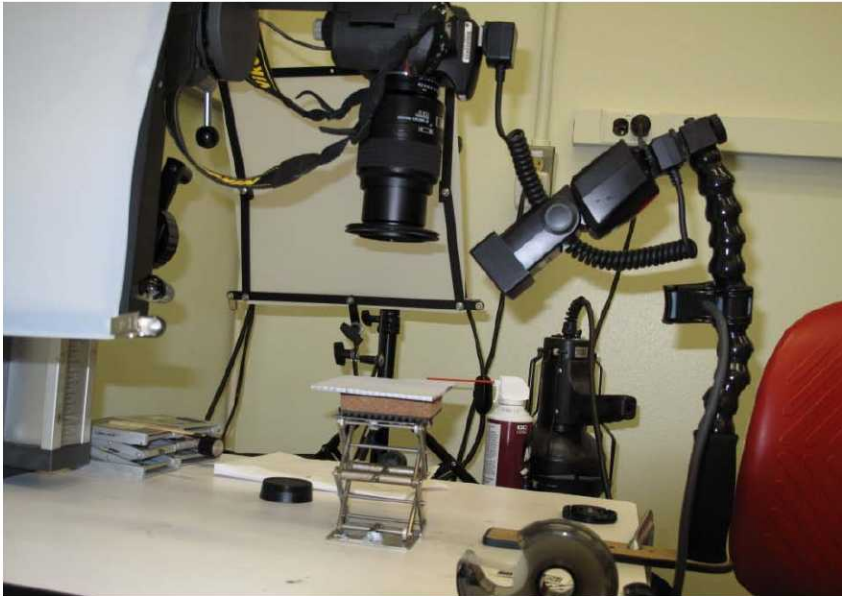
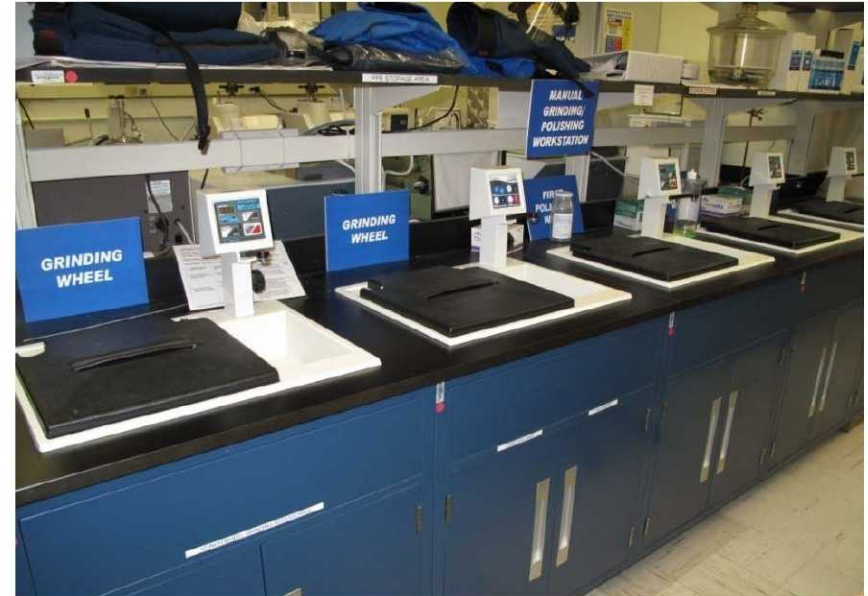
"V" Investigation Cont'

- Sand off surface in 1 mil increments with grinding wheel
 - 500 grit ($18\text{ }\mu\text{m}$) followed by 800 grit ($12\text{ }\mu\text{m}$)
- Lightly etch Surface – Kroll (2% HF, 4% HNO_3 , 96% H_2O)
- Document again with SEM and perform fluorescent penetrant testing at each stage

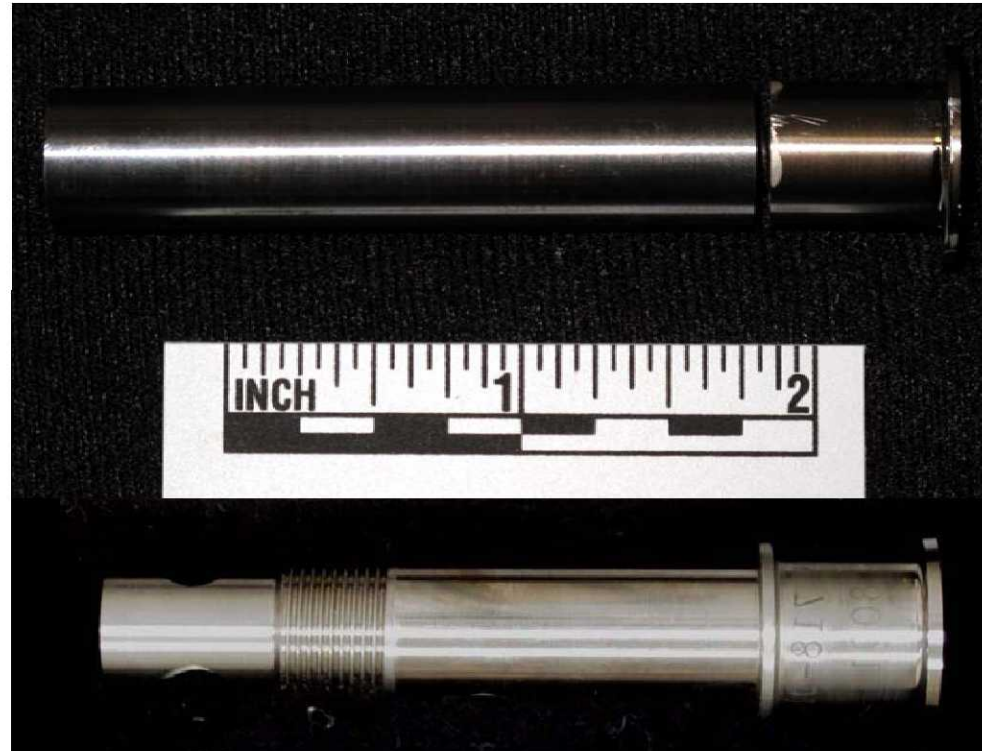
Poppet Investigation

- Document Langley fatigue cracked and flight FCV poppets in SEM
- Perform penetrant (P-136E & P6F4) tests on Langley fatigue cracked poppets
 - Focused on largest cracks
 - Spot application
 - Solvent wipe

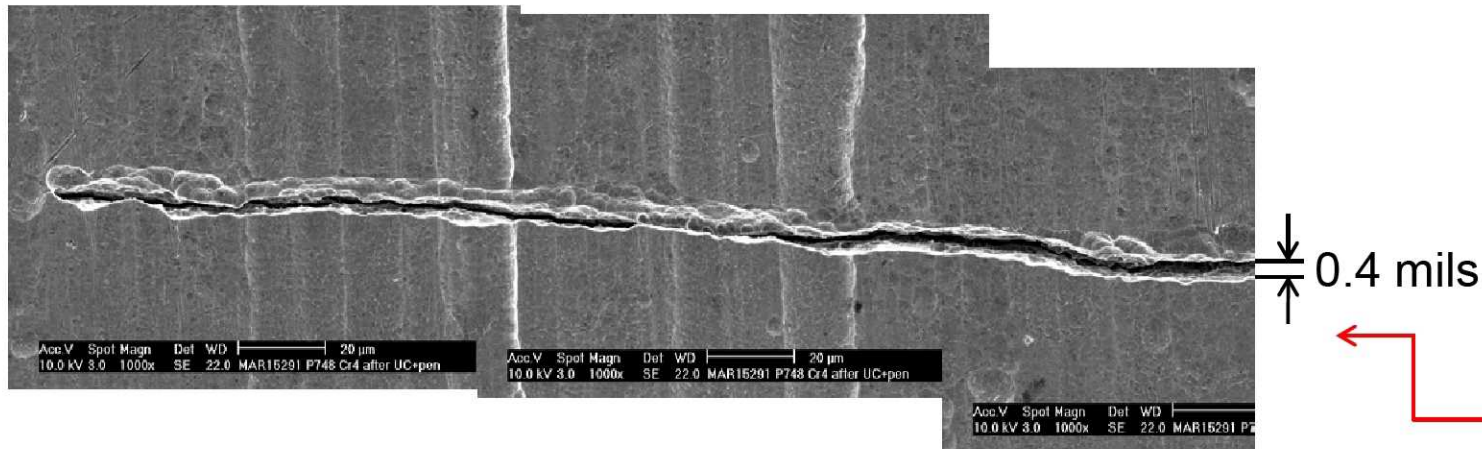
As Received

"V" Investigation SEM Photos

- The “V” did not significantly affect our ability to detect the POD cracks with fluorescent penetrant
 - Conduct same experiment with more cracks
- The 0.025 and 0.050 POD specimens are clean and documented with the SEM
 - Conduct water-wash fluorescent penetrant test at EAFB
- The poppet cracks are tighter than the POD specimen cracks
 - Flight FCV poppets: 0.01 mils (0.3 μm)
 - Langley fatigue cracked poppets: 0.02 mils (0.5 μm)
 - POD specimen (post 5 mils): 0.05 mils (1.4 μm)
- We could not detect cracks in Langley fatigue-cracked poppets with fluorescent penetrant
 - Investigate inability of penetrant to wet the poppet surface

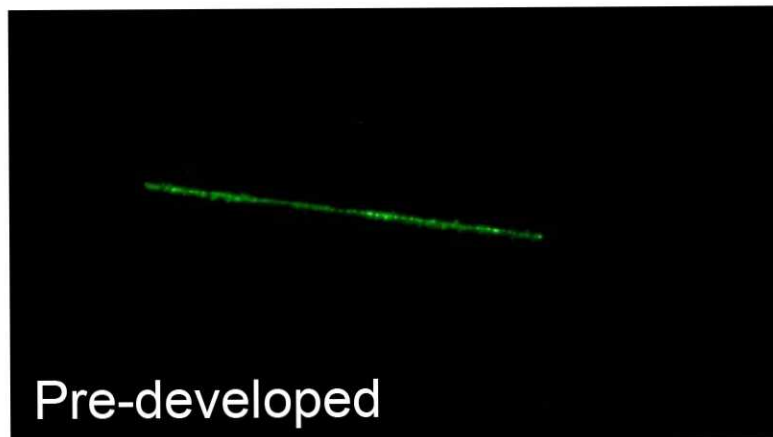
As Received

"V" Investigation Penetrant Photos

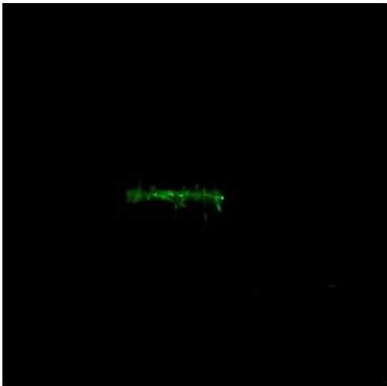
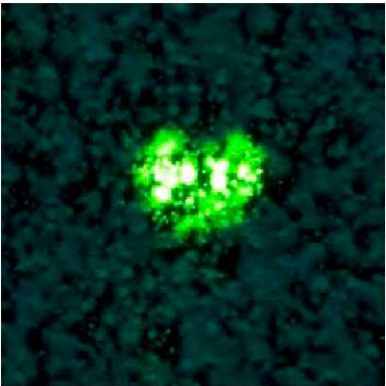
Specimen	Length (inches)	Pre-develop Rating	Post-develop Rating	Pre-develop Photograph	Post-develop Photograph
2Y19-3	0.025	1	1

- From the testing we were able to determine all the cracks within the test range were detectable or better with developer
- Many of the indications after development lost their linearity and gave circular indications
- Our tests were performed in a laboratory and our procedure would be difficult in an industrial setting

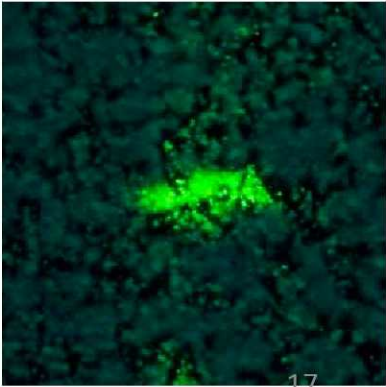
K703-2	0.026	1	1
